# Identifying Delamination

Delamination has various particular characteristics - below are examples to help identify it.

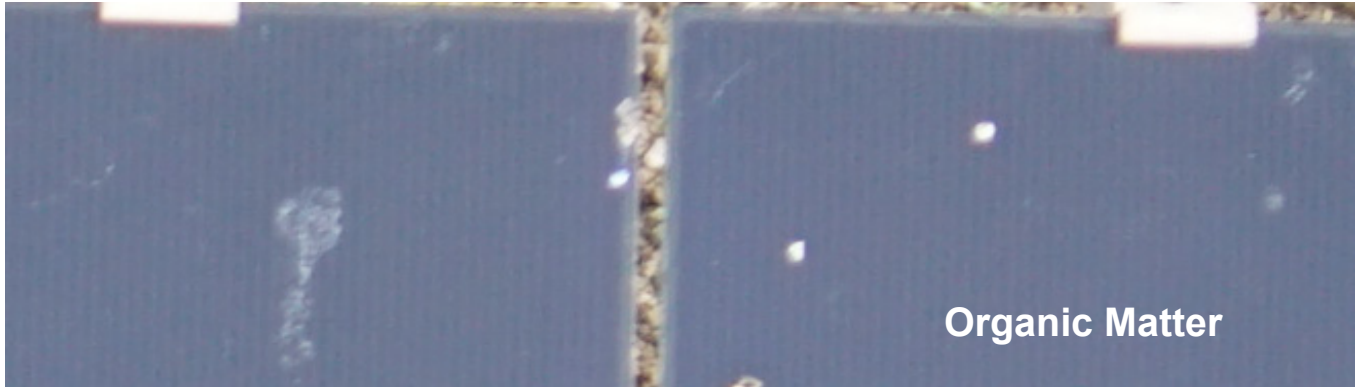
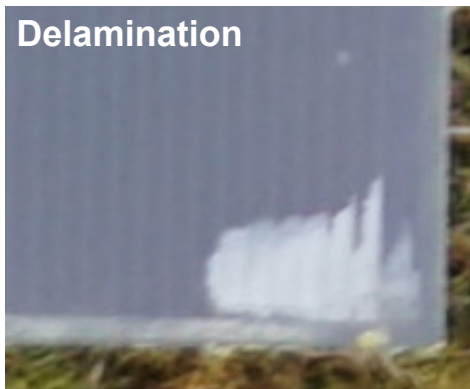
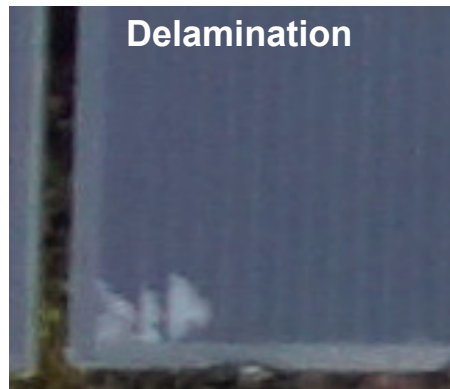
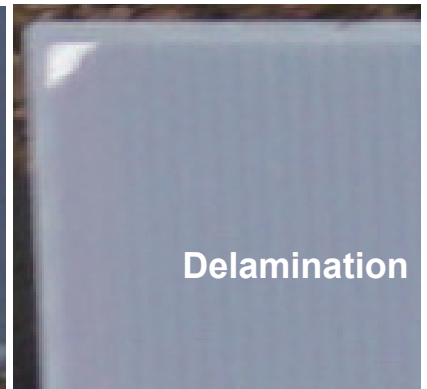
Delamination is caused by a separation of the layers making up the panels, and therefore occurs inside the glass, rather than on top of it. This means that cases of delamination sometimes have a slight blue tone to them. Delamination often has some symmetry, following the electrical lines within the glass, this differs from most organic matter - as can be seen by the comparison below.

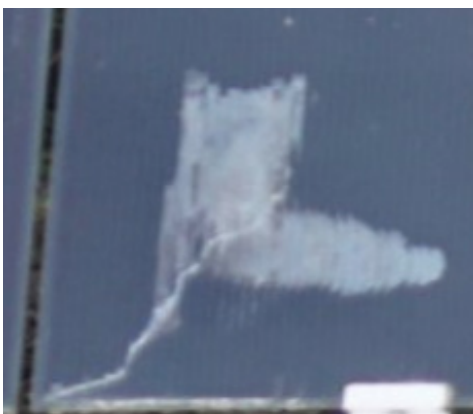
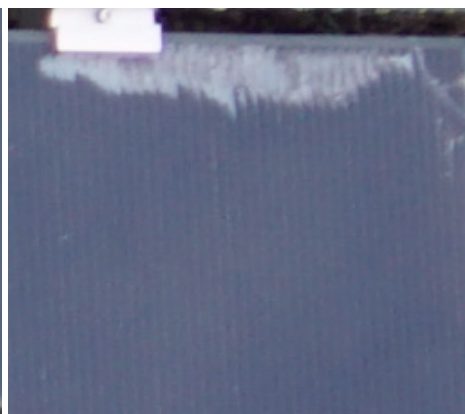
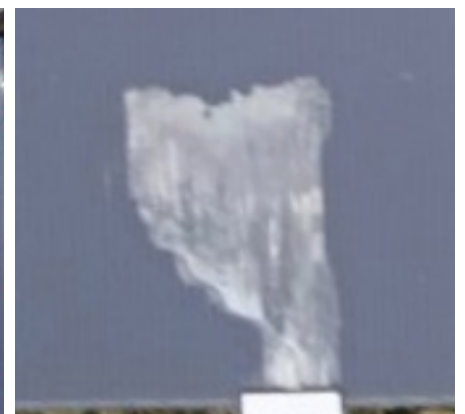
## Damage

Delamination occurs almost exclusively in the corners of the panels, and this is where the analysis should be focused - occasionally, damage to a panel can cause the panel to delaminate, but where delamination has an obvious cause as in the following examples, these are not necessary to be reported:

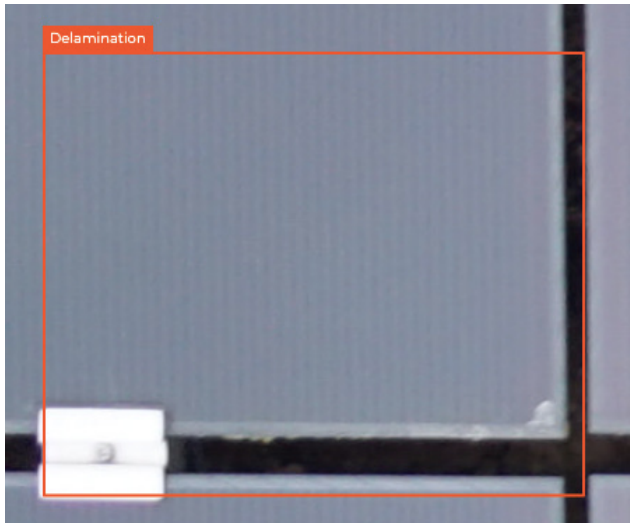
Delamination starts as very small specs in the corners of the panels - below is an explanation of how to identify smaller corner delamination:

The first example is a slightly more progressed fault, while the other two show the very beginning of these faults.

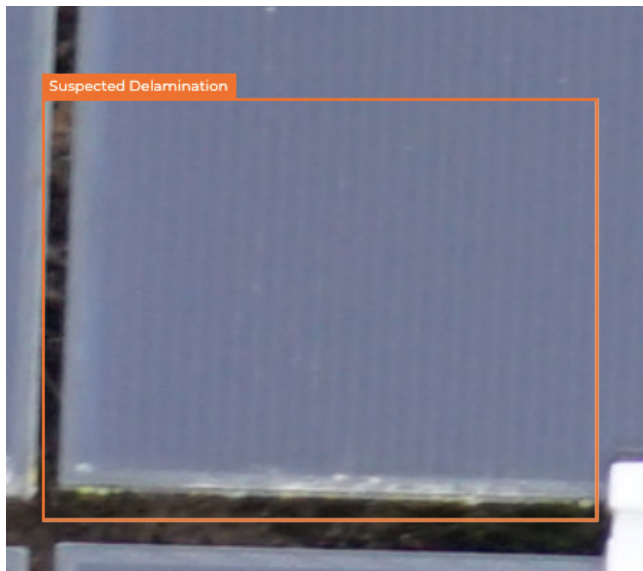
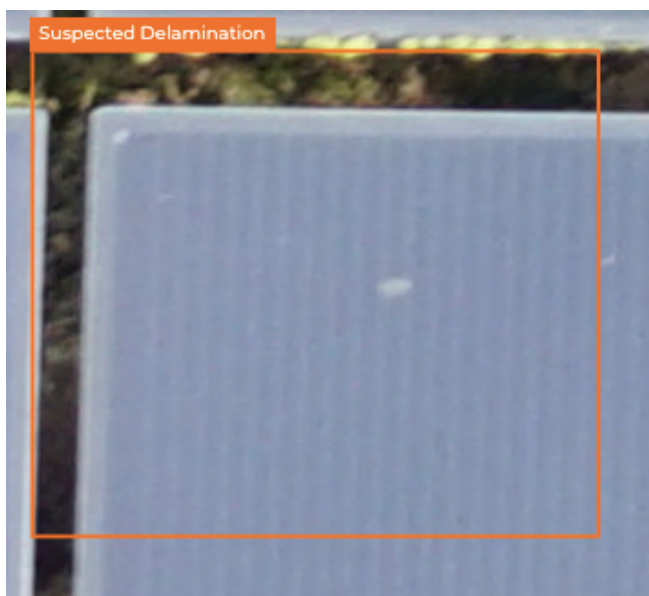
Note that while they are slightly different in shape and size, they all sit symmetrically within the corner seals:
